Old Oakland Road Habitat Mitigation Project
Story Road Mitigation Site #2

Year 5 (2009) Monitoring Report

**OLD OAKLAND ROAD HABITAT MITIGATION PROJECT
STORY ROAD MITIGATION SITE No. 2**

YEAR 5 (2009)

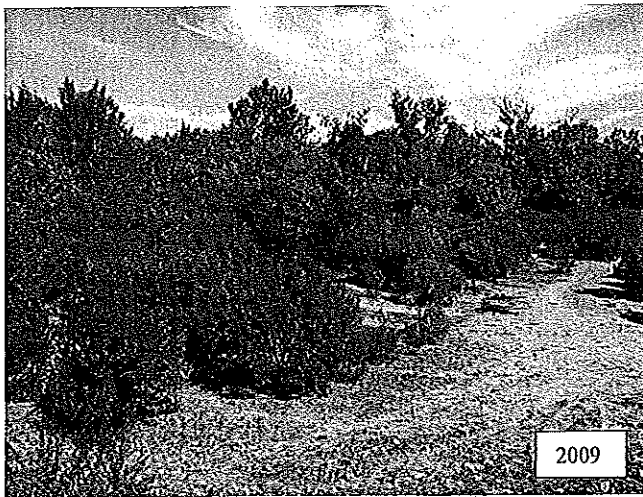
Figure 4. View of westernmost portion of riparian planting area, Year 5 - August 2009. (Photo station #1)

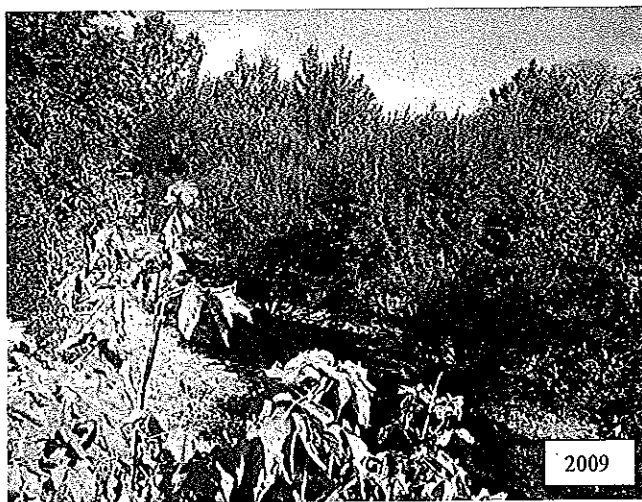
Figure 7B. View of Sample Plot 1, August 2009. Herbaceous/bare cover is 20%; shrub cover is 60% and tree cover is 20%. Natural recruitment by coyote brush.

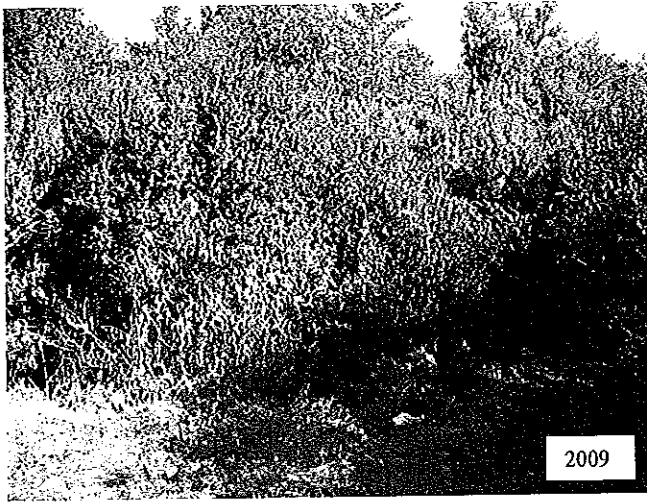
Figure 8B. View of Sample Plot 2, August 2009. Herbaceous/bare cover is 10%; shrub cover is 90% and tree cover is 0%. Trash and human waste is prevalent in this area.

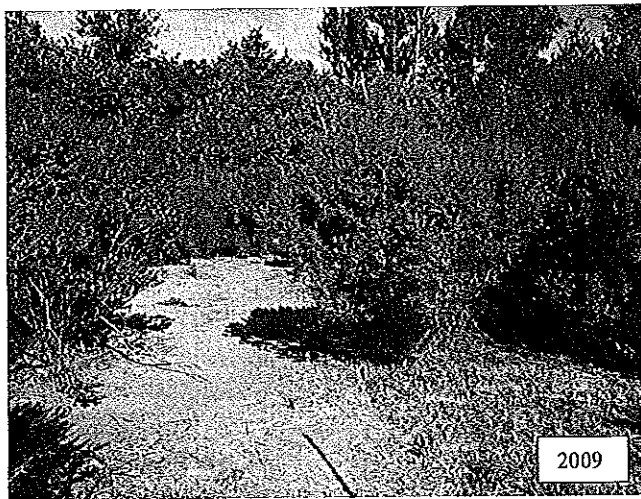
Figure 10B. View of Sample Plot 4, August 2009. Herbaceous/bare cover is 10%; shrub cover is 90% and tree cover is 0%. Natural recruitment of coyote brush. A foot trail traverses this area and human waste is prevalent.

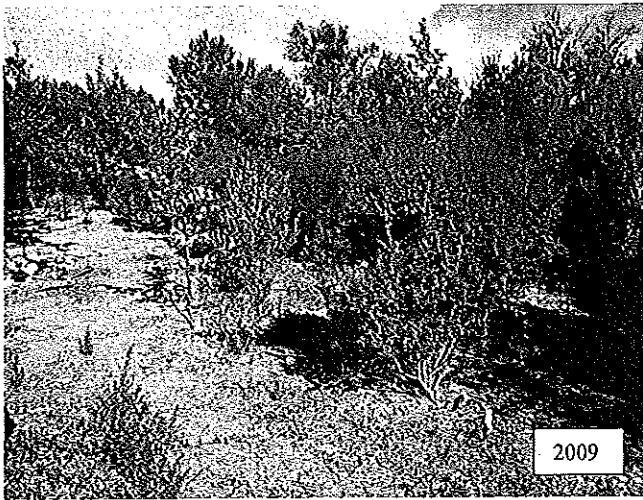
Figure 11B. View of Sample Plot 5, August 2009. Herbaceous/bare cover is 40%; shrub cover is 28%, tree cover is 3020%. And bare is 2%. Natural recruitment by coyote brush. Note trash pile nearby.

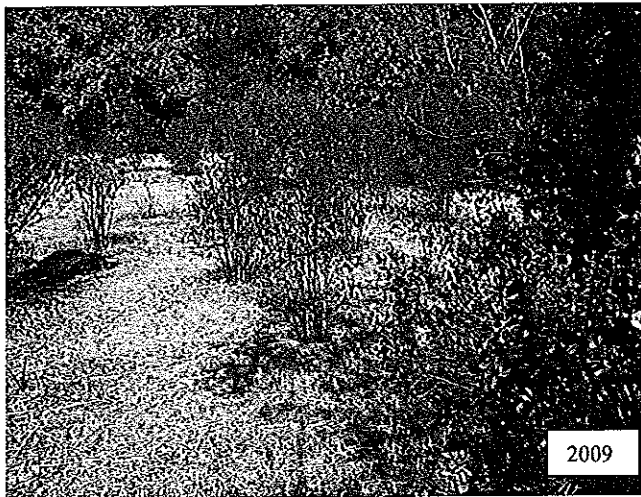
Figure 13B. View of Sample Plot 7, August 2009. Herbaceous/bare cover is 30%; shrub cover is 40% and tree cover is 30%. Snowberry affected by summer drought stress.

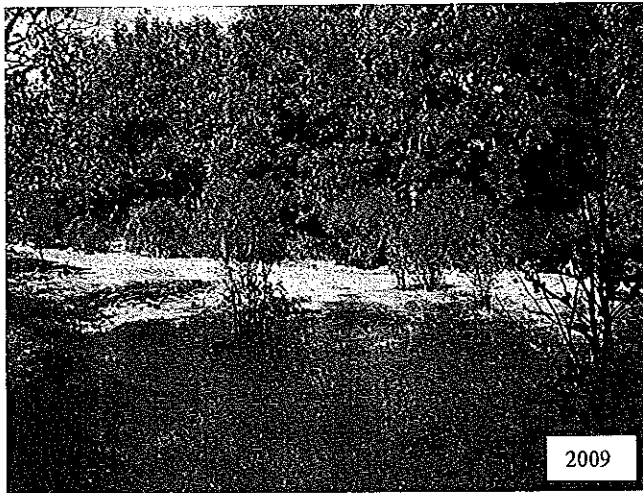
Figure 14B. View of Sample Plot 8, August 2009. Herbaceous/bare cover is 40%; shrub cover is 30% and tree cover is 30%. Vegetation in this area is trampled by transient activity.

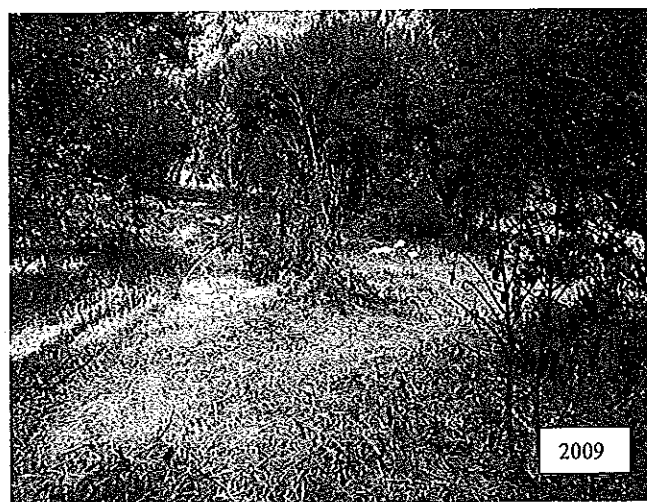
Figure 15B. View of Sample Plot 9, September 2008. Herbaceous/bare cover is 20%; shrub cover is 55% and tree cover is 20%. Note presence of trash/human waste. This site is near two large homeless encampments.

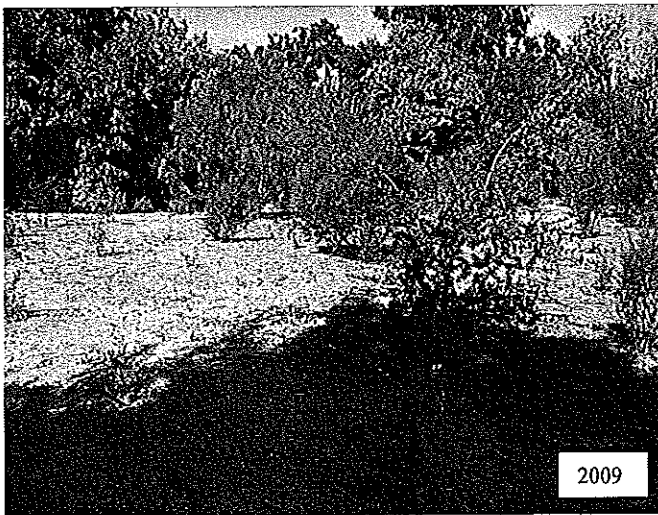
Figure 19B. View of Sample Plot 13, August 2009. Herbaceous/bare cover is 40%; shrub cover is 50%, tree cover is 10%. This area is frequented by transients; a homeless camp (with fed-feral cats) is nearby.

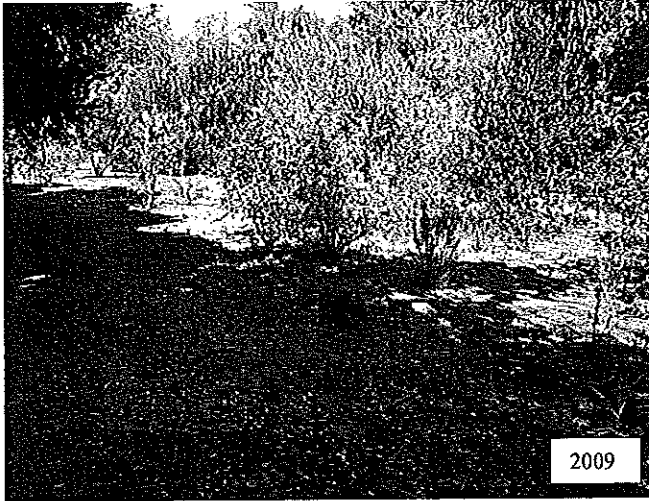
Figure 20B. View of Sample Plot 14, August 2009. Herbaceous cover and bare is 95%; shrub cover is 5%, tree cover is 0%. Weeds include tree-of-heaven. This area is frequented by transients; a homeless camp (with fed-feral cats) is nearby.

As recommended in previous monitoring reports, the City should remove trees/tree groves of tree-of-heaven (invasive species) that abut the mitigation area. This tree removal plan is presented in Appendix A. The removal of these invasive trees will provide long-term benefits to the mitigation area, as tree-of-heaven can aggressively invade the mitigation area once maintenance activities cease.

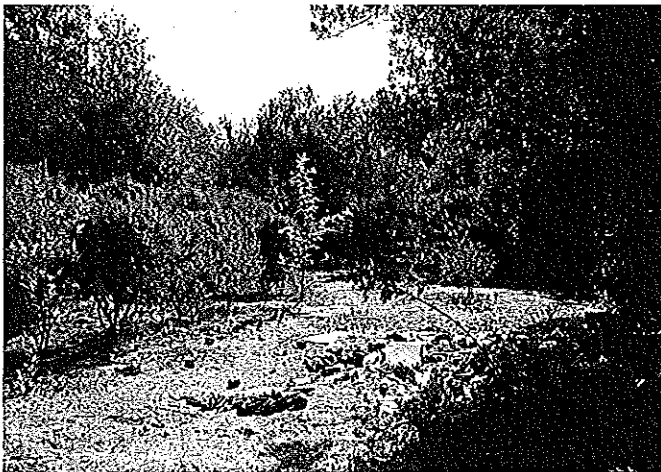
The riparian mitigation area, as well as the adjoining riparian woodland along Coyote Creek, continues to be significantly impacted by numerous homeless/transient encampments, trash, and human waste. As depicted in Figures 23 and 24, trash has been deposited within many areas within and/or immediately adjacent to the mitigation area. Some trash has been deposited in large piles (as depicted in Figure 23) while human waste (and accompanying sanitary products) is littered throughout the site. In addition to compromising the integrity of the mitigation area from the creation of foot trails and trampling of vegetation, these human activities degrade the value of the riparian mitigation area and the adjacent riparian woodland for native riparian-dependent wildlife. The abundance of exposed human waste is expected to be a health hazard, which may become a water quality problem within nearby Coyote Creek during the rainy season.

Figure 23. Trash pile deposited within mitigation area (near sample plot 5), August 2009

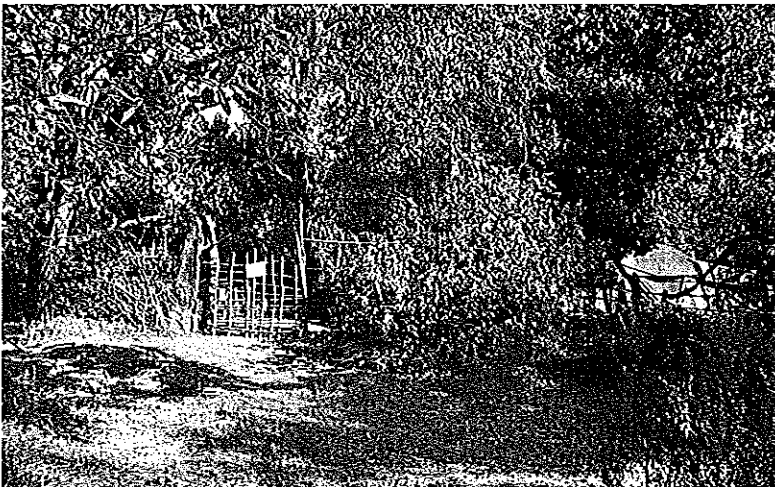
Both domesticated and feral dogs and cats were observed amid the encampments; the presence of these animals reduces the value of the mitigation area for native wildlife. Other activities observed during the Year 5 monitoring include: firewood collection and use of wood fires for cooking, construction of multi-tent campsites, wood fencing around tent camp sites (Figure 24) and use of propane stoves. Periodic vandalism of the mitigation areas irrigation system also occurred in 2009.

Figure 24. Homeless encampment along edge of mitigation area and along edge of Coyote Creek. The camp supports tents and a wooden fence. A dog was observed in August 2009.

other City departments, as applicable, is needed to control the number of homeless encampments and reduce the amount of trash and human waste deposited within the riparian area.
